Repair of Utility Cuts Within Interlocking Concrete Pavements

Interlocking Concrete
Pavement Institute®

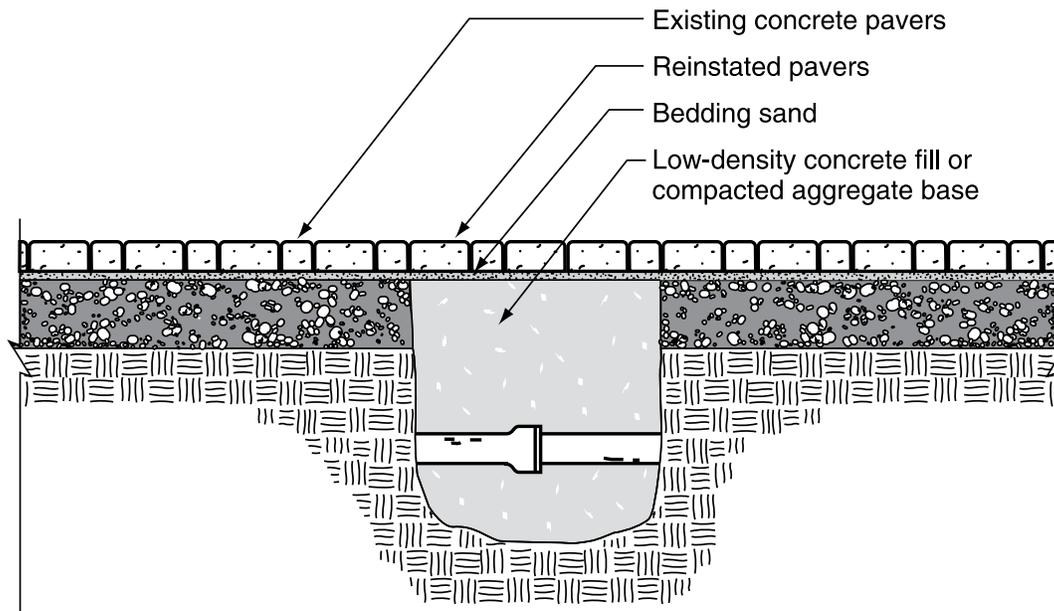
Figure 6. Cross section of reinstated utility cut into interlocking concrete pavement.

Figures 2, 3, 4, 5 and 6 show the process of repair and illustrate the continuity of the paver surface after it is completed. The

Repaired utility lines are typically wrapped in plastic prior to pouring the low density fill. This keeps the concrete from bonding to the lines and enables them to move independently. When the fill is poured, it is self-leveling. It should be poured to within 4 in. (100 mm) of the riding surface to accommodate 3.125 in. (80 mm) thick concrete pavers and 1 in. (25 mm) of bedding sand.

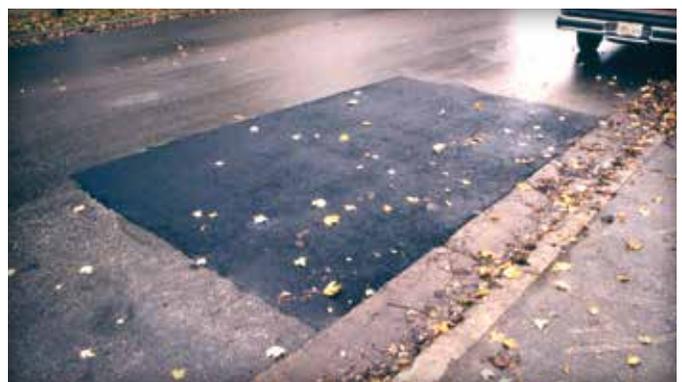
Figure 7. Pavement damage from settlement and shrinkage of cold patch asphalt.
